HISTORIC AMERICAN BUILDINGS SURVEY
INVENTORY

2. NAME *Orrin Thompson Mansion*

DATE OR PERIOD *1832*
STYLE *Greek Revival*
ARCHITECT
BUILDER *Orrin Thompson*

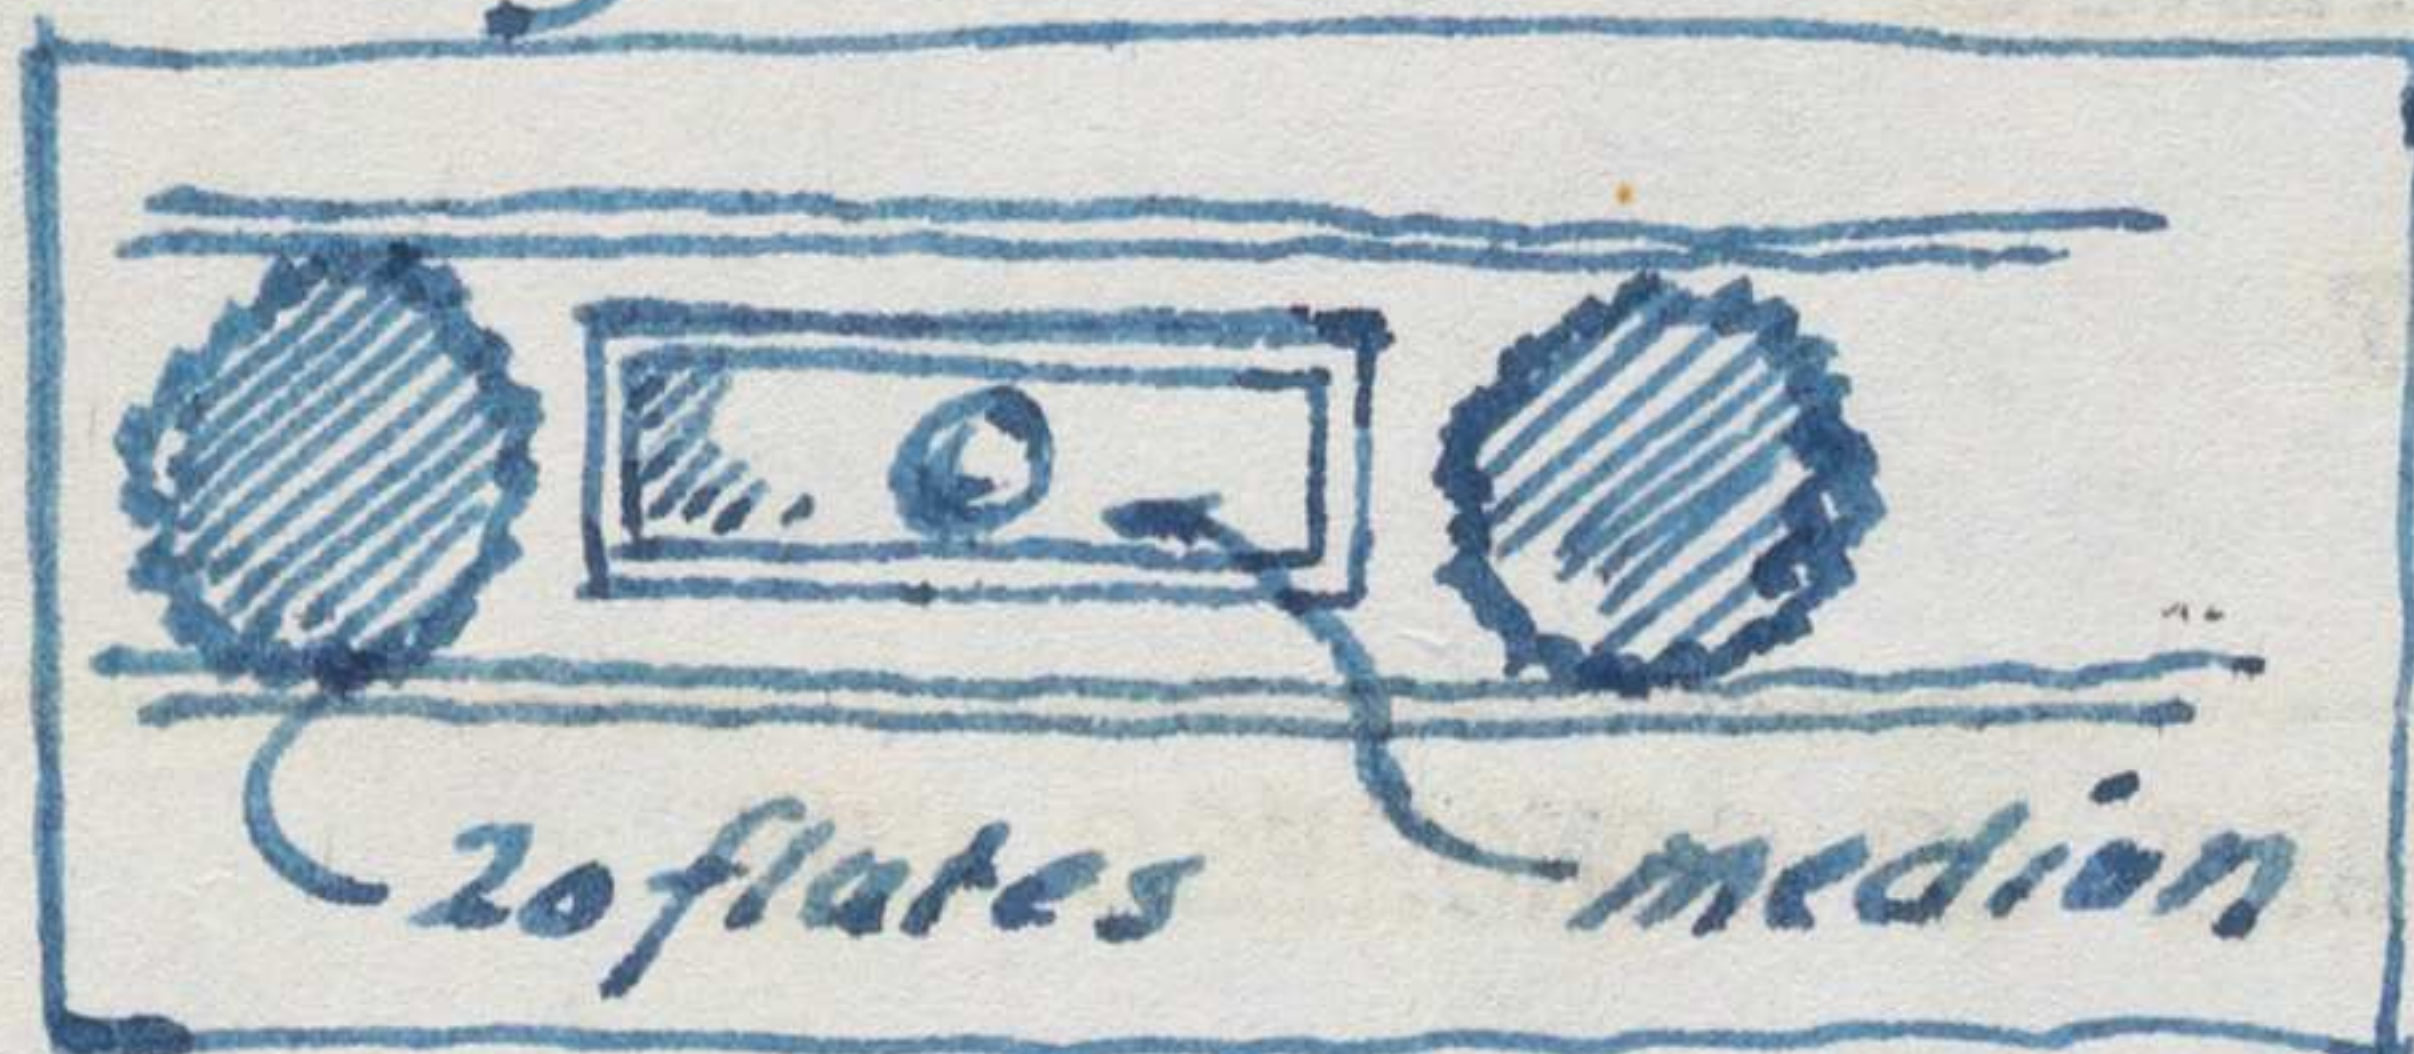
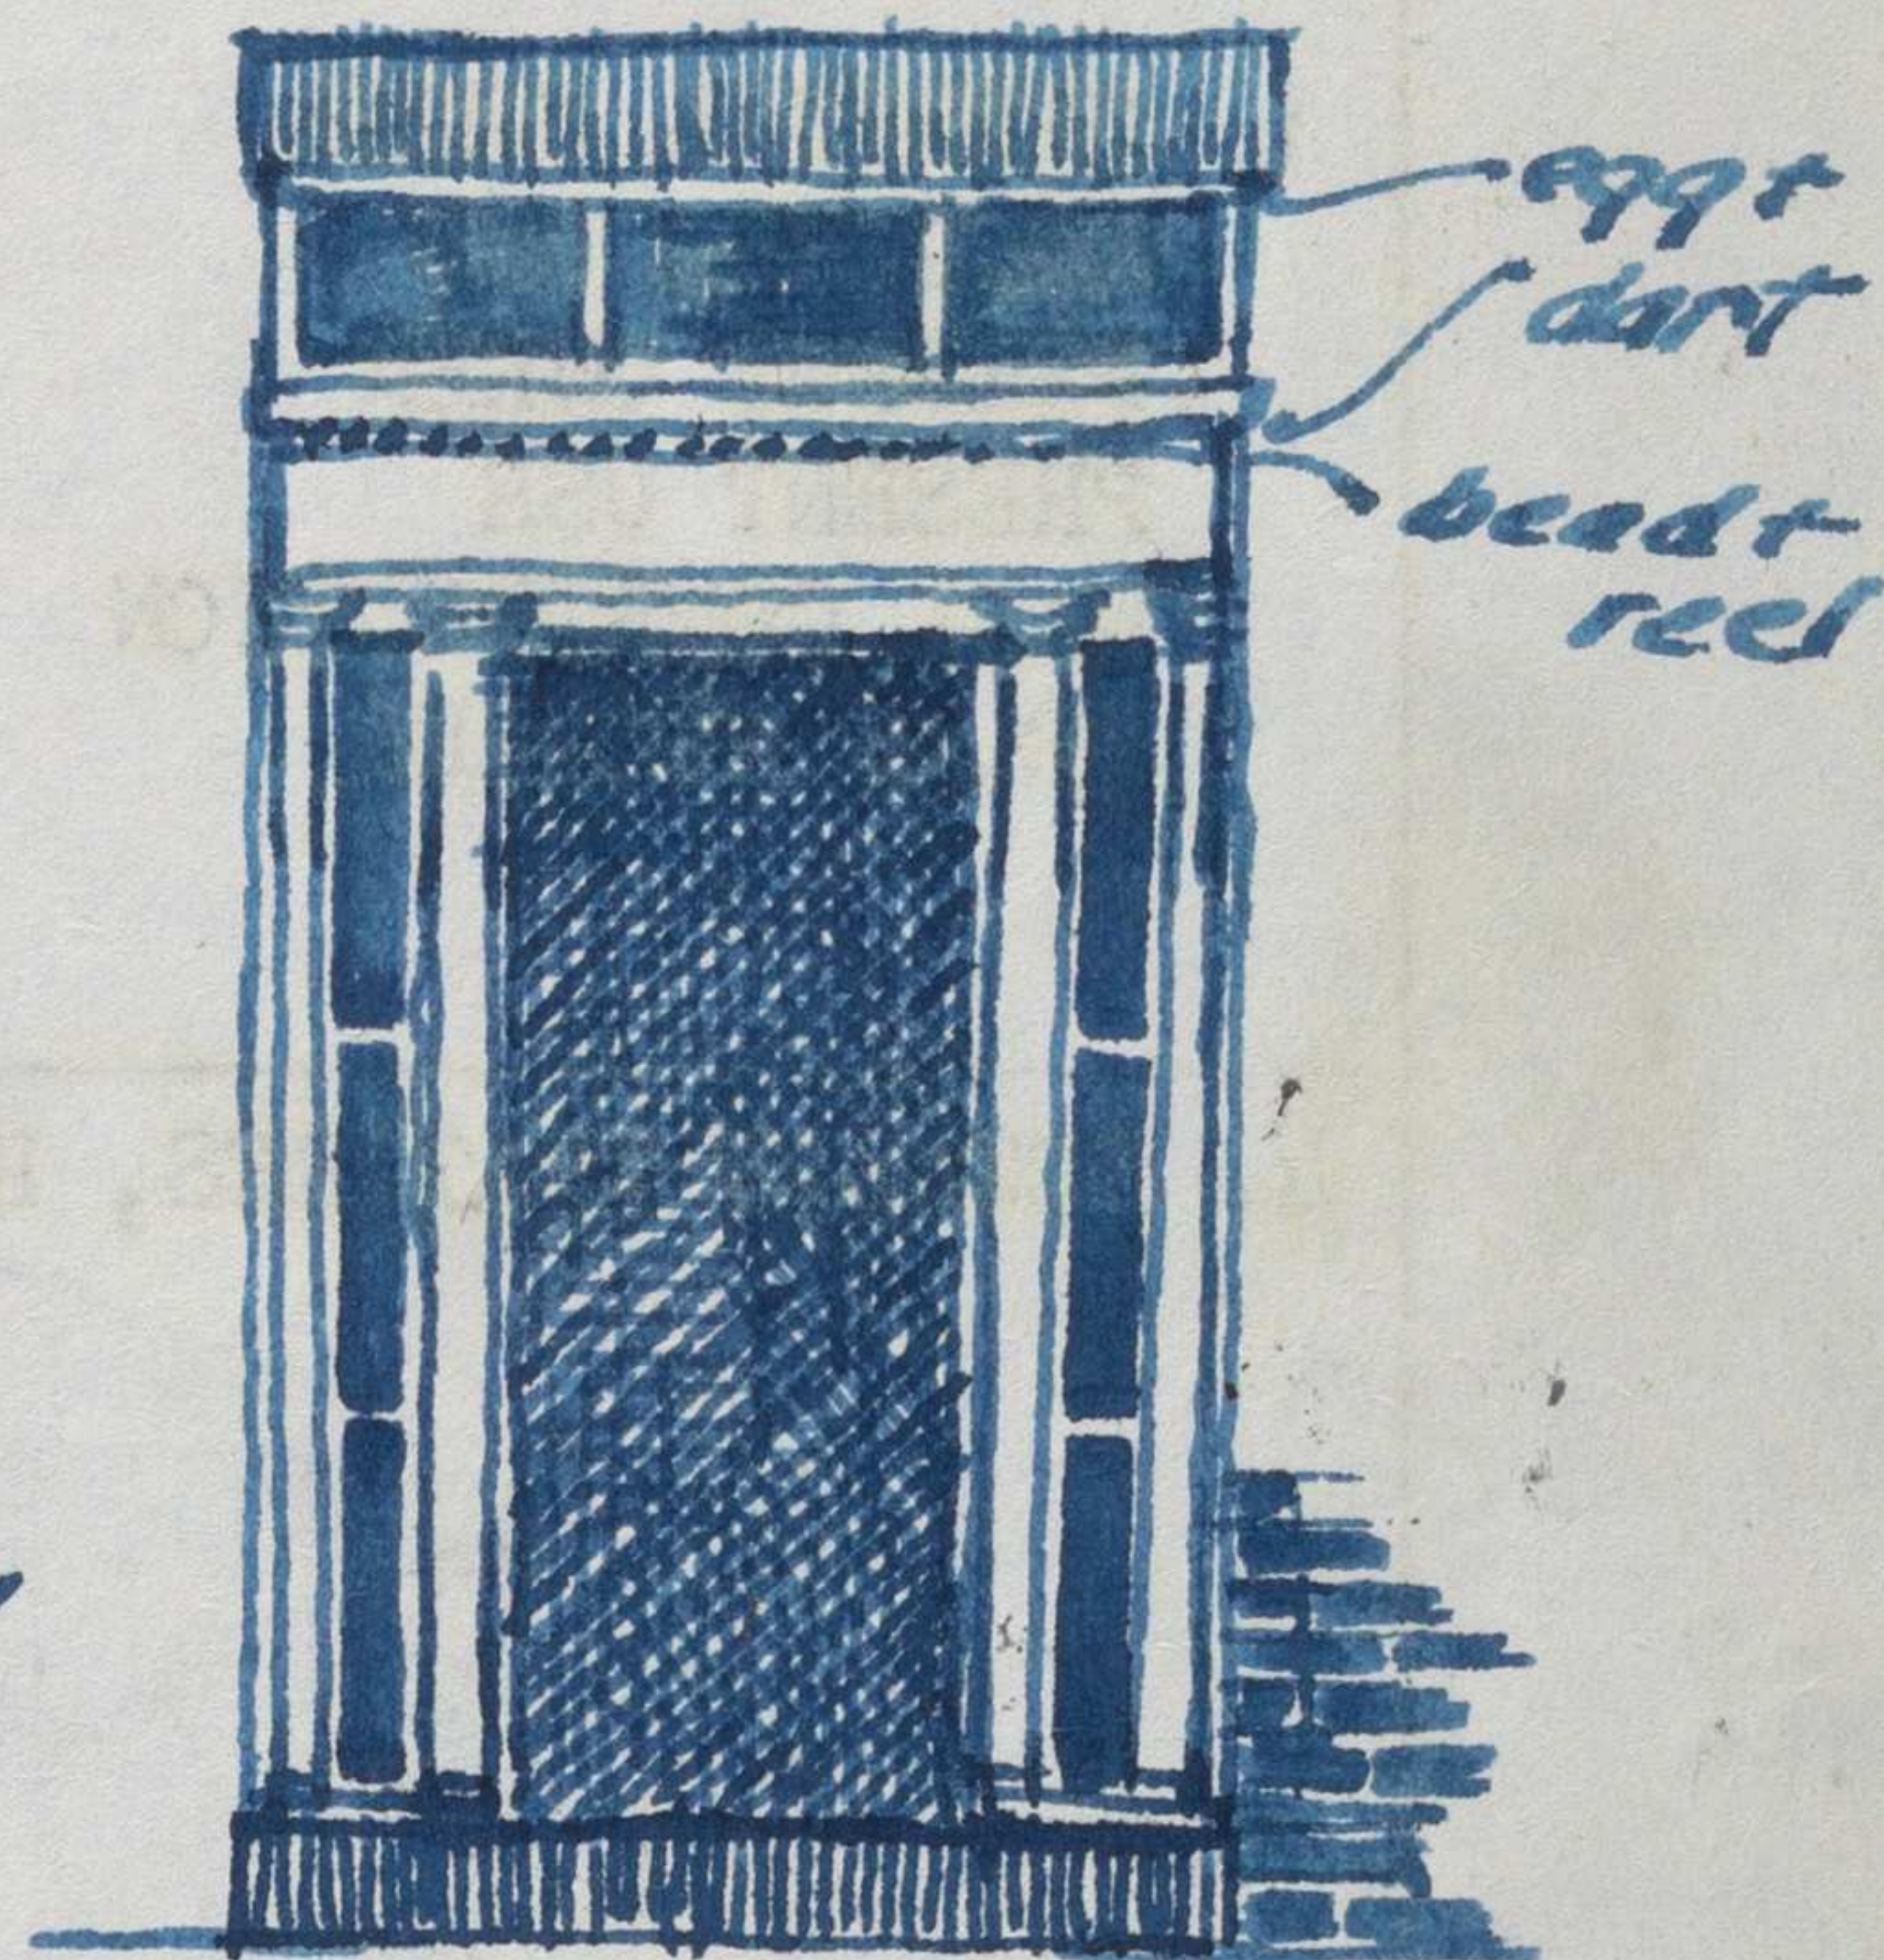
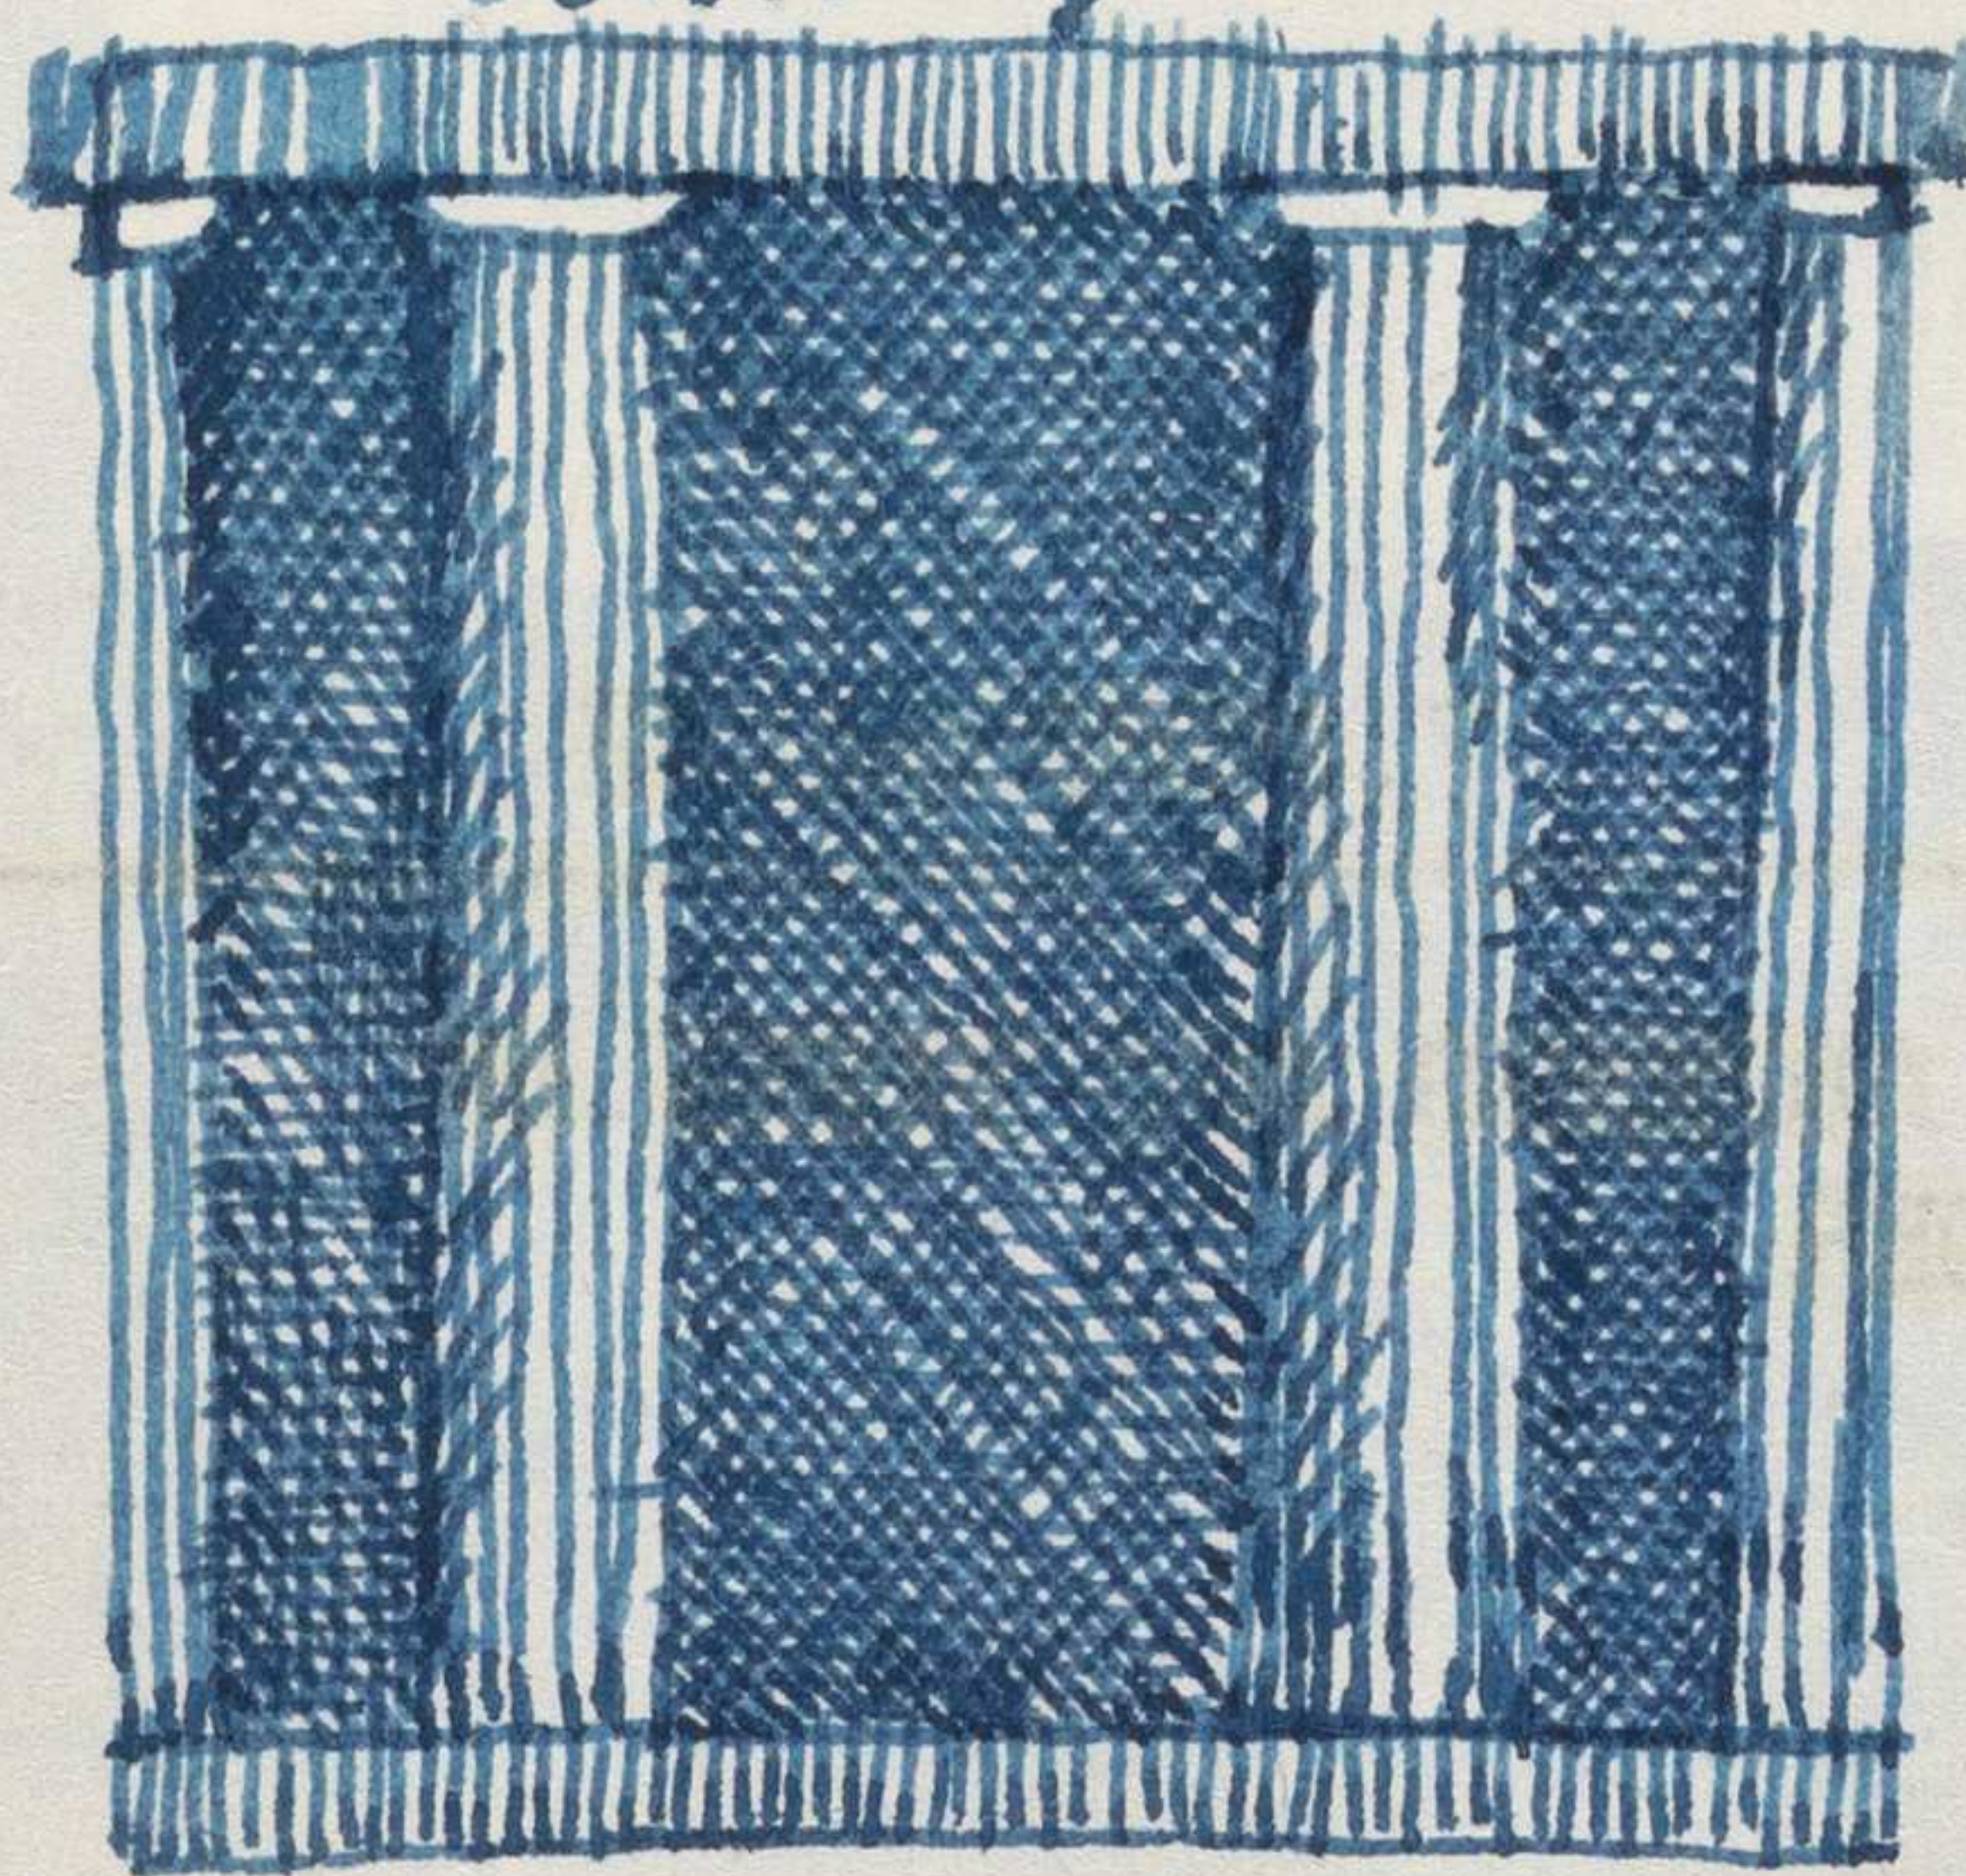
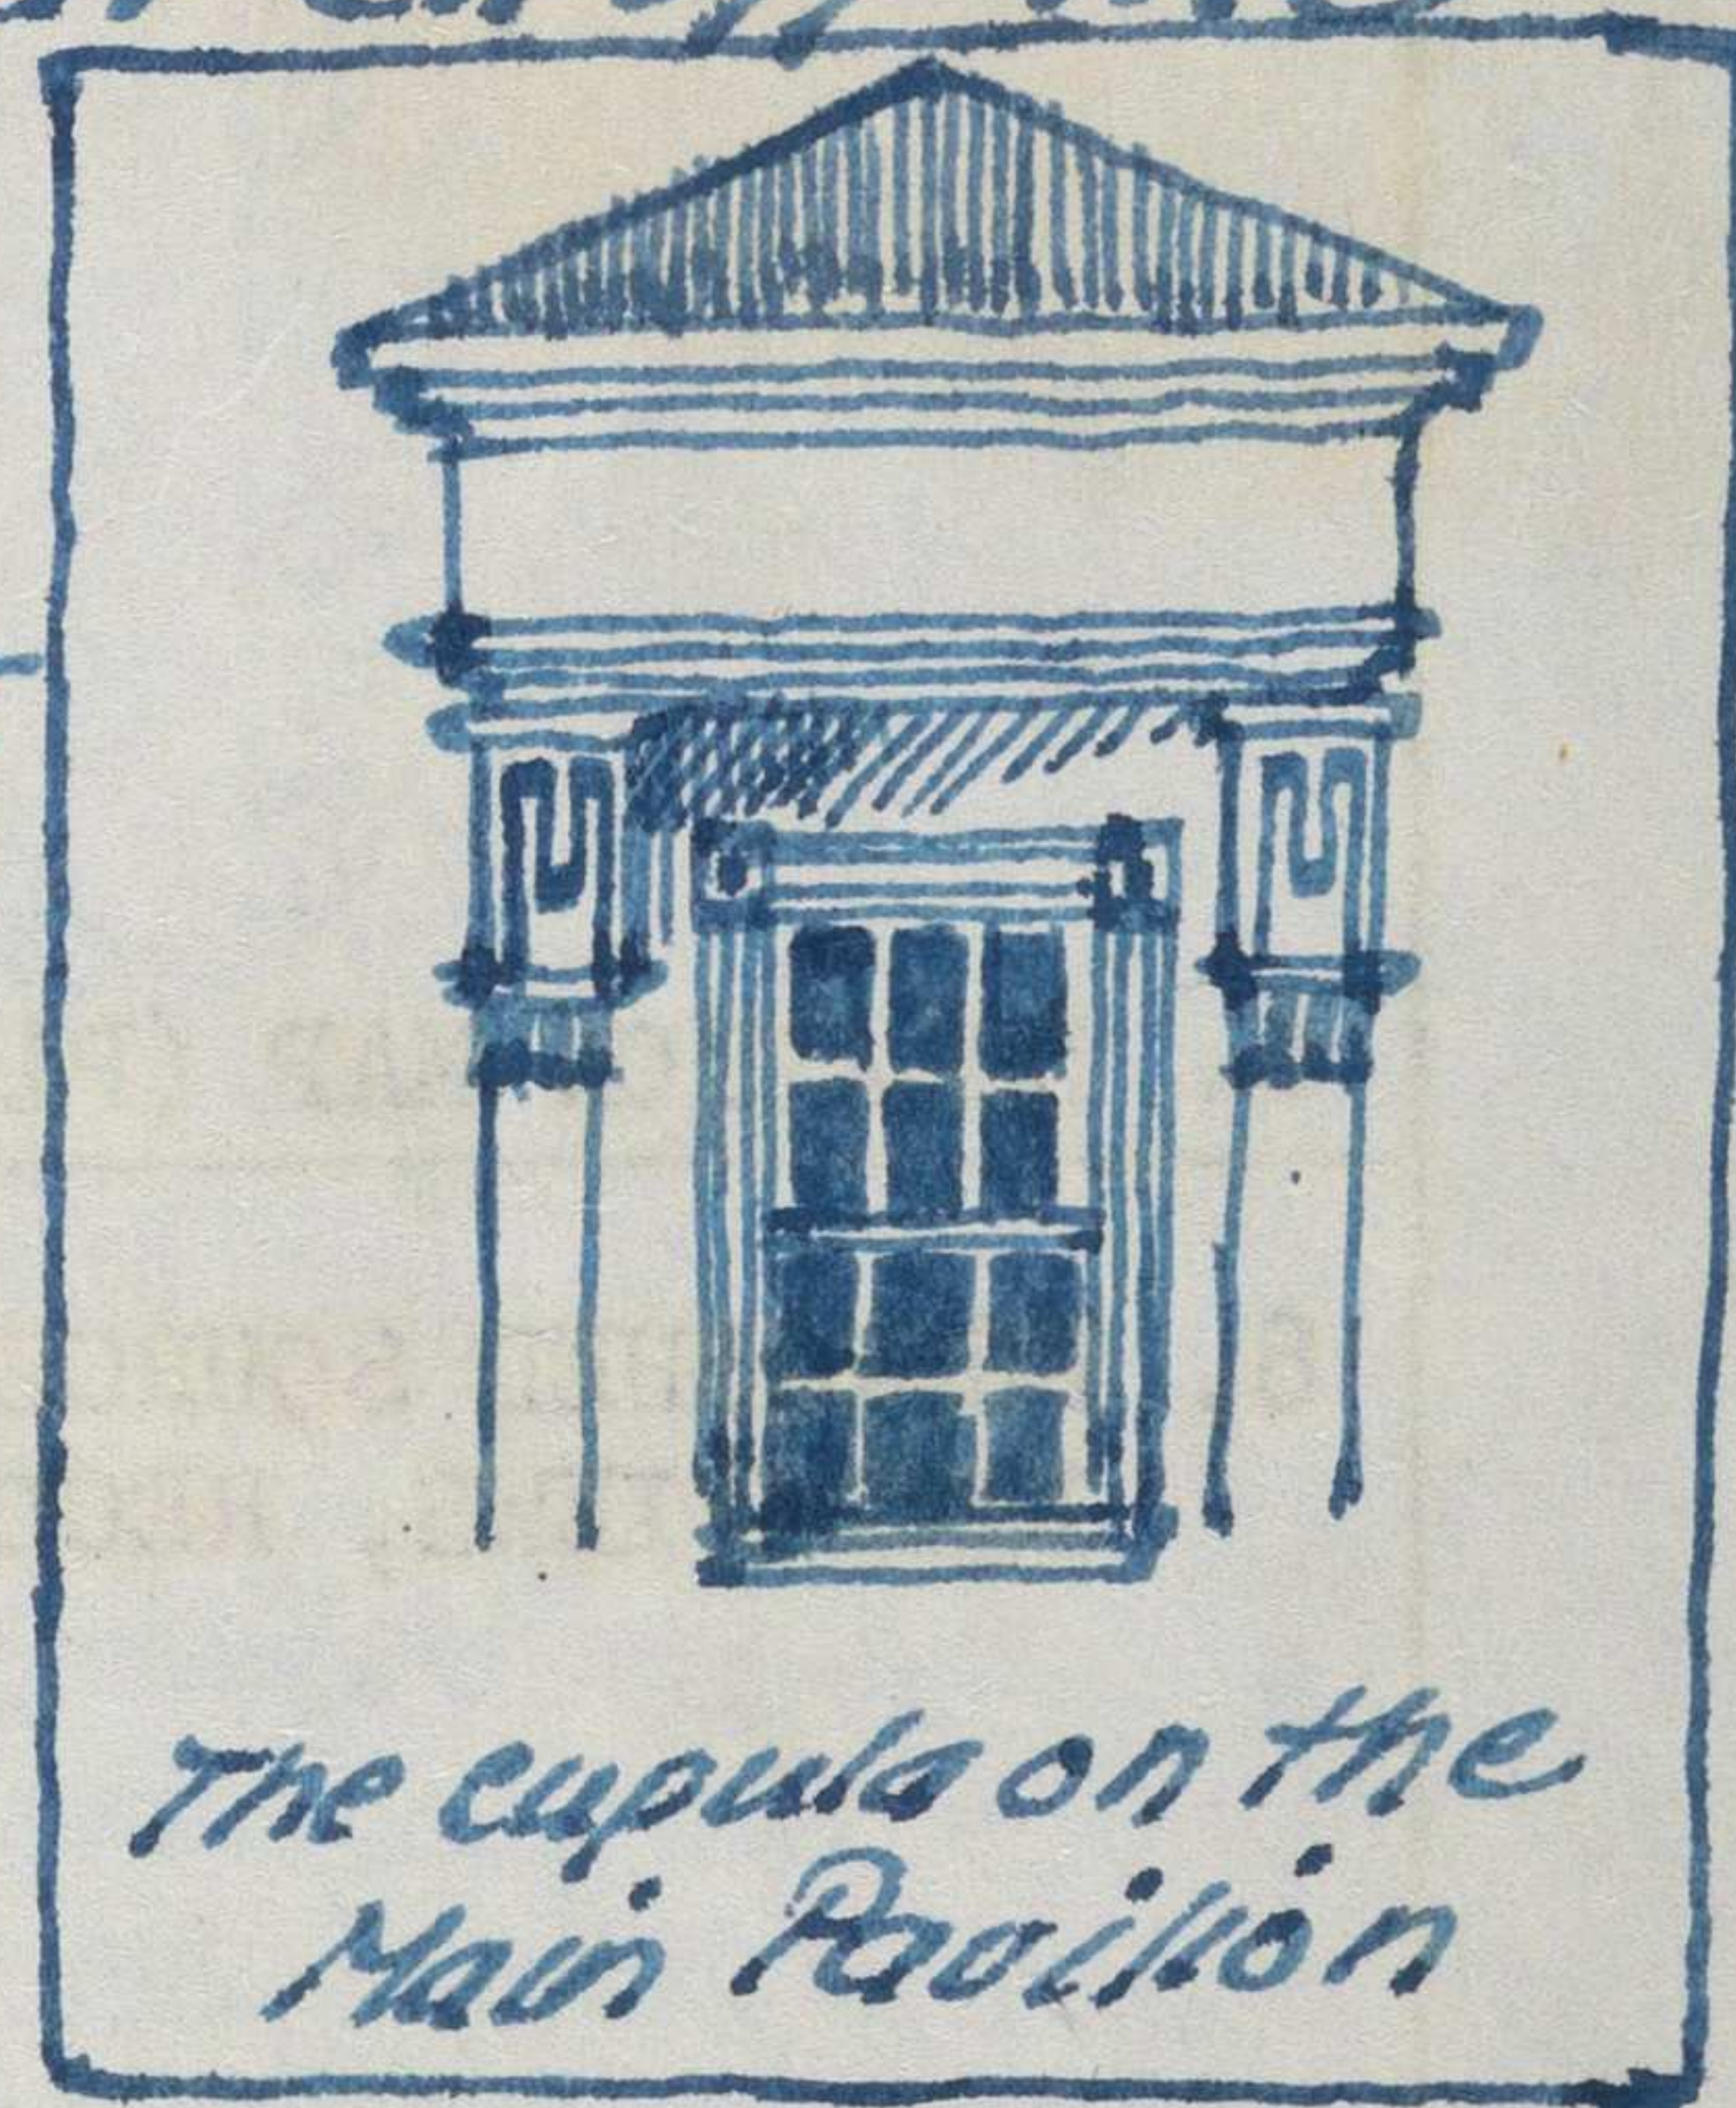
magnificent 20 flute Greek Doric columnade marking each 3 bay side pavilion. Each doorway is absolutely splendid,

embodying several of the basic Greek ornamental forms in its basic fabric. The door

itself in both cases is a replacement. The windows of the house are all of the 1/6 variety but the windows of the main pavilion have panes a full 20 inches long, making the windows themselves some 4 feet long. The rooms inside this portion must have 14 (or so) foot ceilings. All the windows are surmounted with simple brownstone lintels. The sills are of the same material. The very shallow sloping roofs are placed above full plain entablatures. Strangely the corners of the main pavilion have painted pilasters, made simply by painting the red brick white to that design. The rear of the house has several other Doric porches, one being a porch of one story made up of 6 columns about a door on the ^{South} ~~right~~ side of the rear facade of the main pavilion. The other is the distyle and antus form being in front of a recessed porch on the south side of the rear ell off the main pavilion. Today due to its new

institutional use there are many other additions as well. The ~~at least~~ feature of note is the fine Revival cupula with the familiar key design in its pilasters. At one time there was a ballustrade along

the edge of the roof of the main pavilion to further ornament the crown of the house.

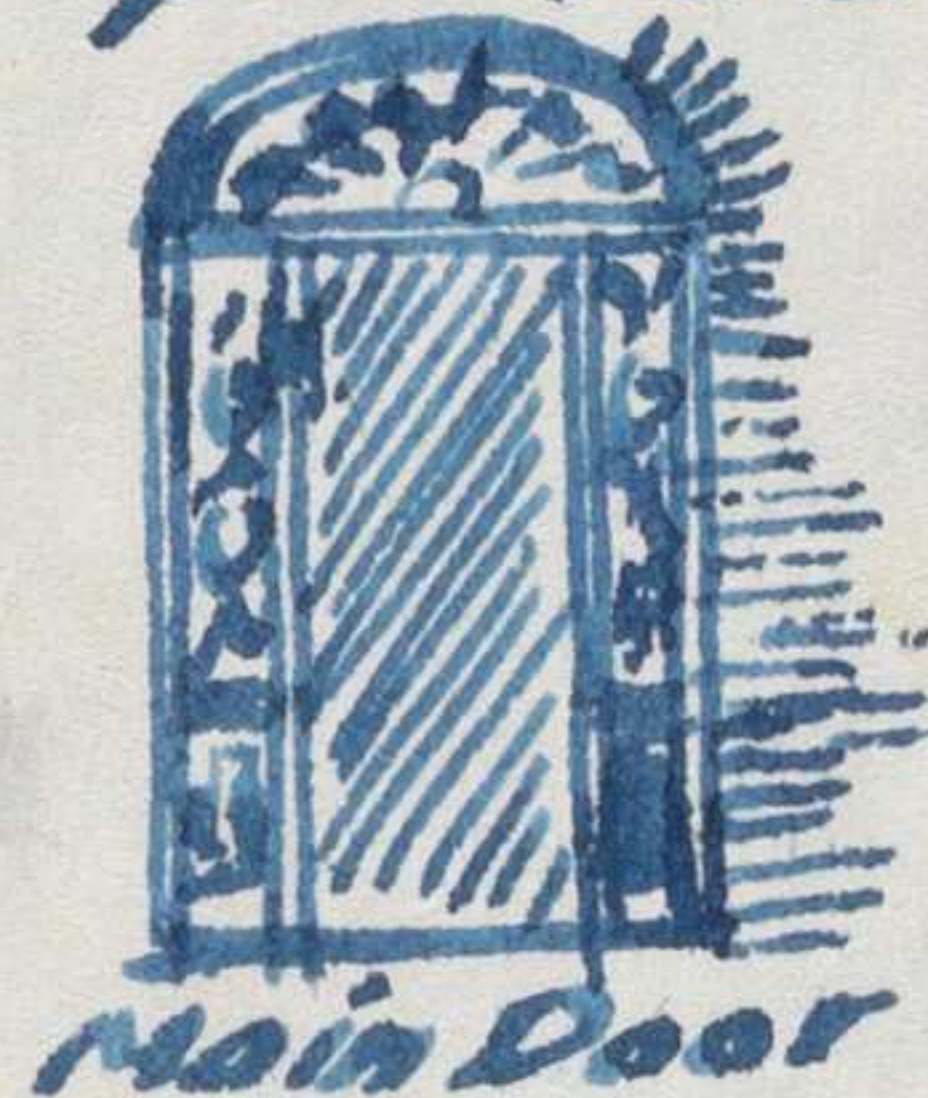
Main Door

Although hidden behind overgrown foundation evergreens, white paint and promotional lettering this house retains its fine features. The main body of the house bears four chimneys at the sides. It is roofed with the shallow pitch of its period. The wooden dentil work is superb. The five bay facade boasts a fine door with segmental arch and original intricate leading. A side door in the ell proceeding from the NW corner of house has a semicircular transom. And the pediments of both main house and ell are centered with large segmental windows. The foundation is of cut brown stone. The interior must have been extensively

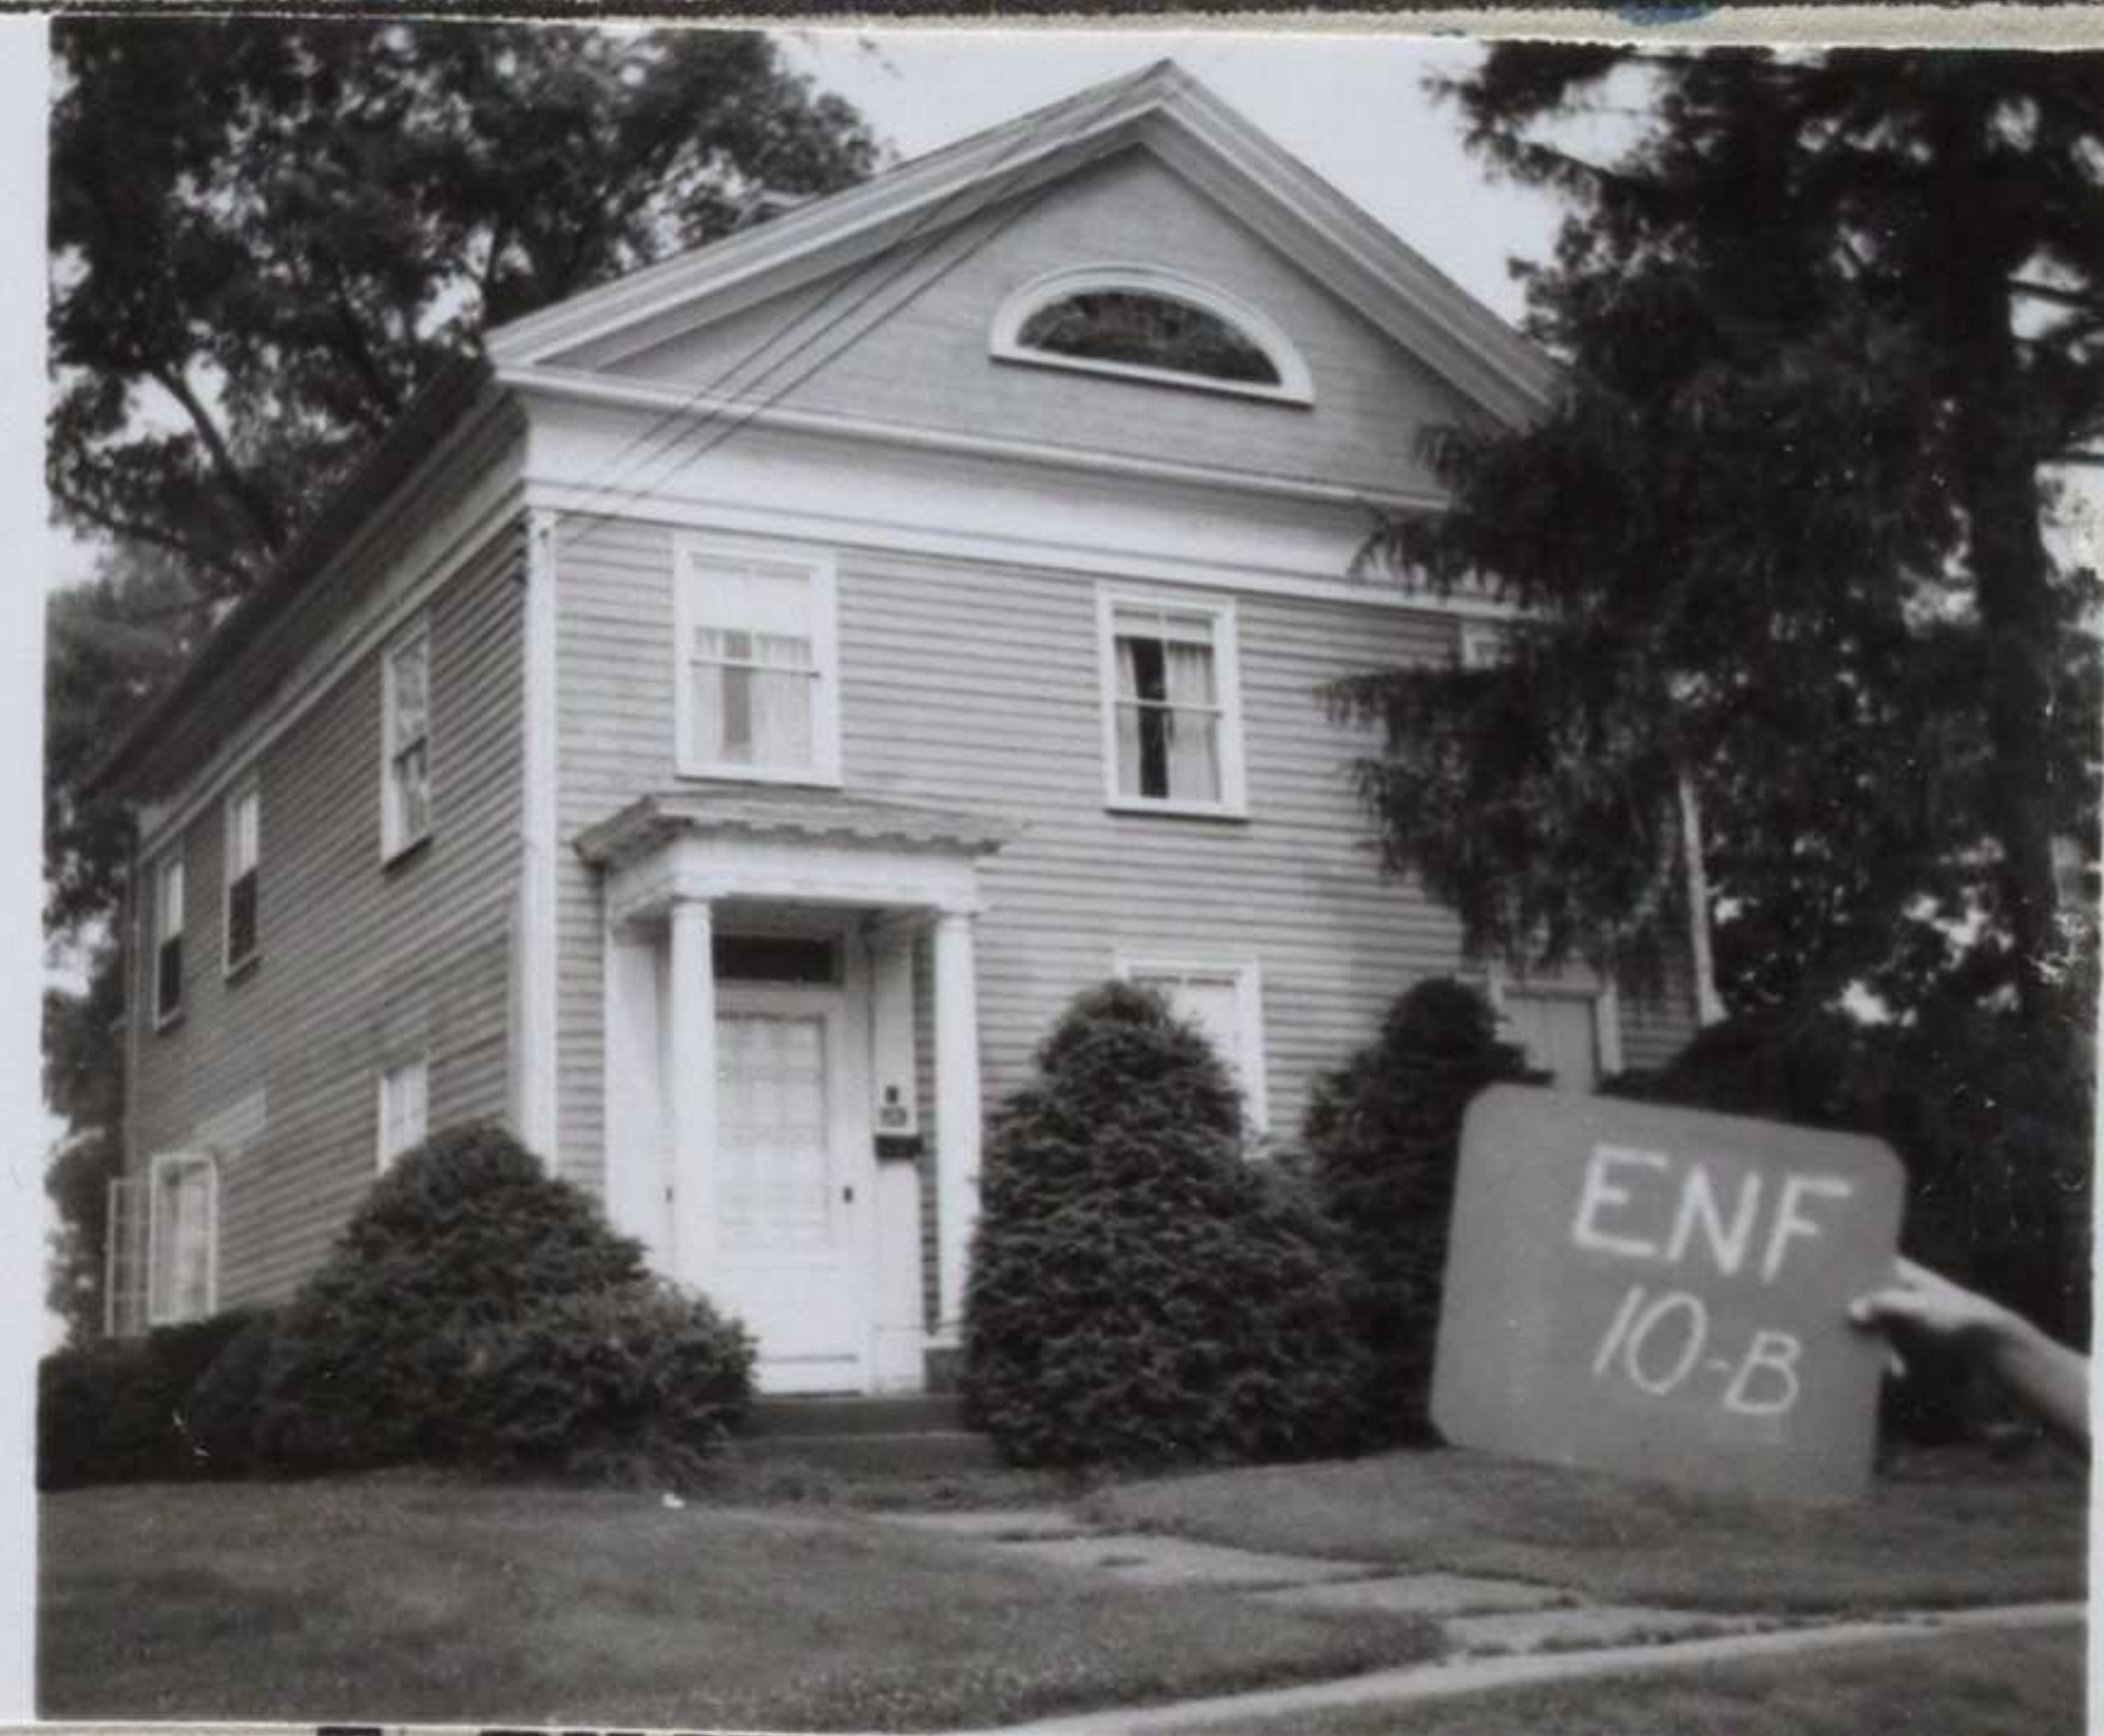
<p>7. PHOTOGRAPH</p>

<p>1. STATE <u>Ct</u> COUNTY <u>Hartford</u> TOWN <u>Enfield</u> VICINITY STREET NO. <u>1280 Enfield Street</u></p> <p>ORIGINAL OWNER <u>2nd Francis L. Robbins</u> ORIGINAL USE <u>Residence</u> PRESENT OWNER <u>Congregational Church</u> PRESENT USE <u>Residence/Parsonage</u> WALL CONSTRUCTION <u>clapboard</u> NO. OF STORIES <u>2</u></p>		<p>HISTORIC AMERICAN BUILDINGS SURVEY INVENTORY</p> <p>2. NAME <u>2nd Francis LeBaron Robbins House</u> DATE OR PERIOD <u>1830</u> STYLE <u>Federal</u> ARCHITECT BUILDER</p> <p>3. FOR LIBRARY OF CONGRESS USE</p>			
<p>4. NOTABLE FEATURES, HISTORICAL SIGNIFICANCE AND DESCRIPTION</p> <p><i>Francis LeBaron Robbins was one of the first Congregational missionaries and later pastor of Enfield for 34 years. He built this house in 1830 and lived here until his death in 1850 when 4 year-old Franklin Sheldon ^{saw and later} recalled in his 1826 memoirs black tunting all over the house and church. It has been the parsonage ever since. The house of three bays, and shallow pitch, formed pediment is built on a brown stone foundation. The detail to ornament of the house is quite ^{marvelous}. The leading of both the doorway, ^{transom and} pedimental window is an example of an "Enfield type." The window is exactly the same as that of #31.</i></p> <p><i>The house bears a full plain entablature, whereas the portico to the doorway is enhanced by an entablature with triglyphs. This supported on plain doric columns and pilasters. The door is original.</i></p>		<p>OPEN TO PUBLIC <u>No</u></p>

<p>5. PHYSICAL CONDITION OF STRUCTURE</p> <p><i>Endangered No Interior fair? Exterior good</i></p>		<p>6. LOCATION MAP (Plan Optional)</p>

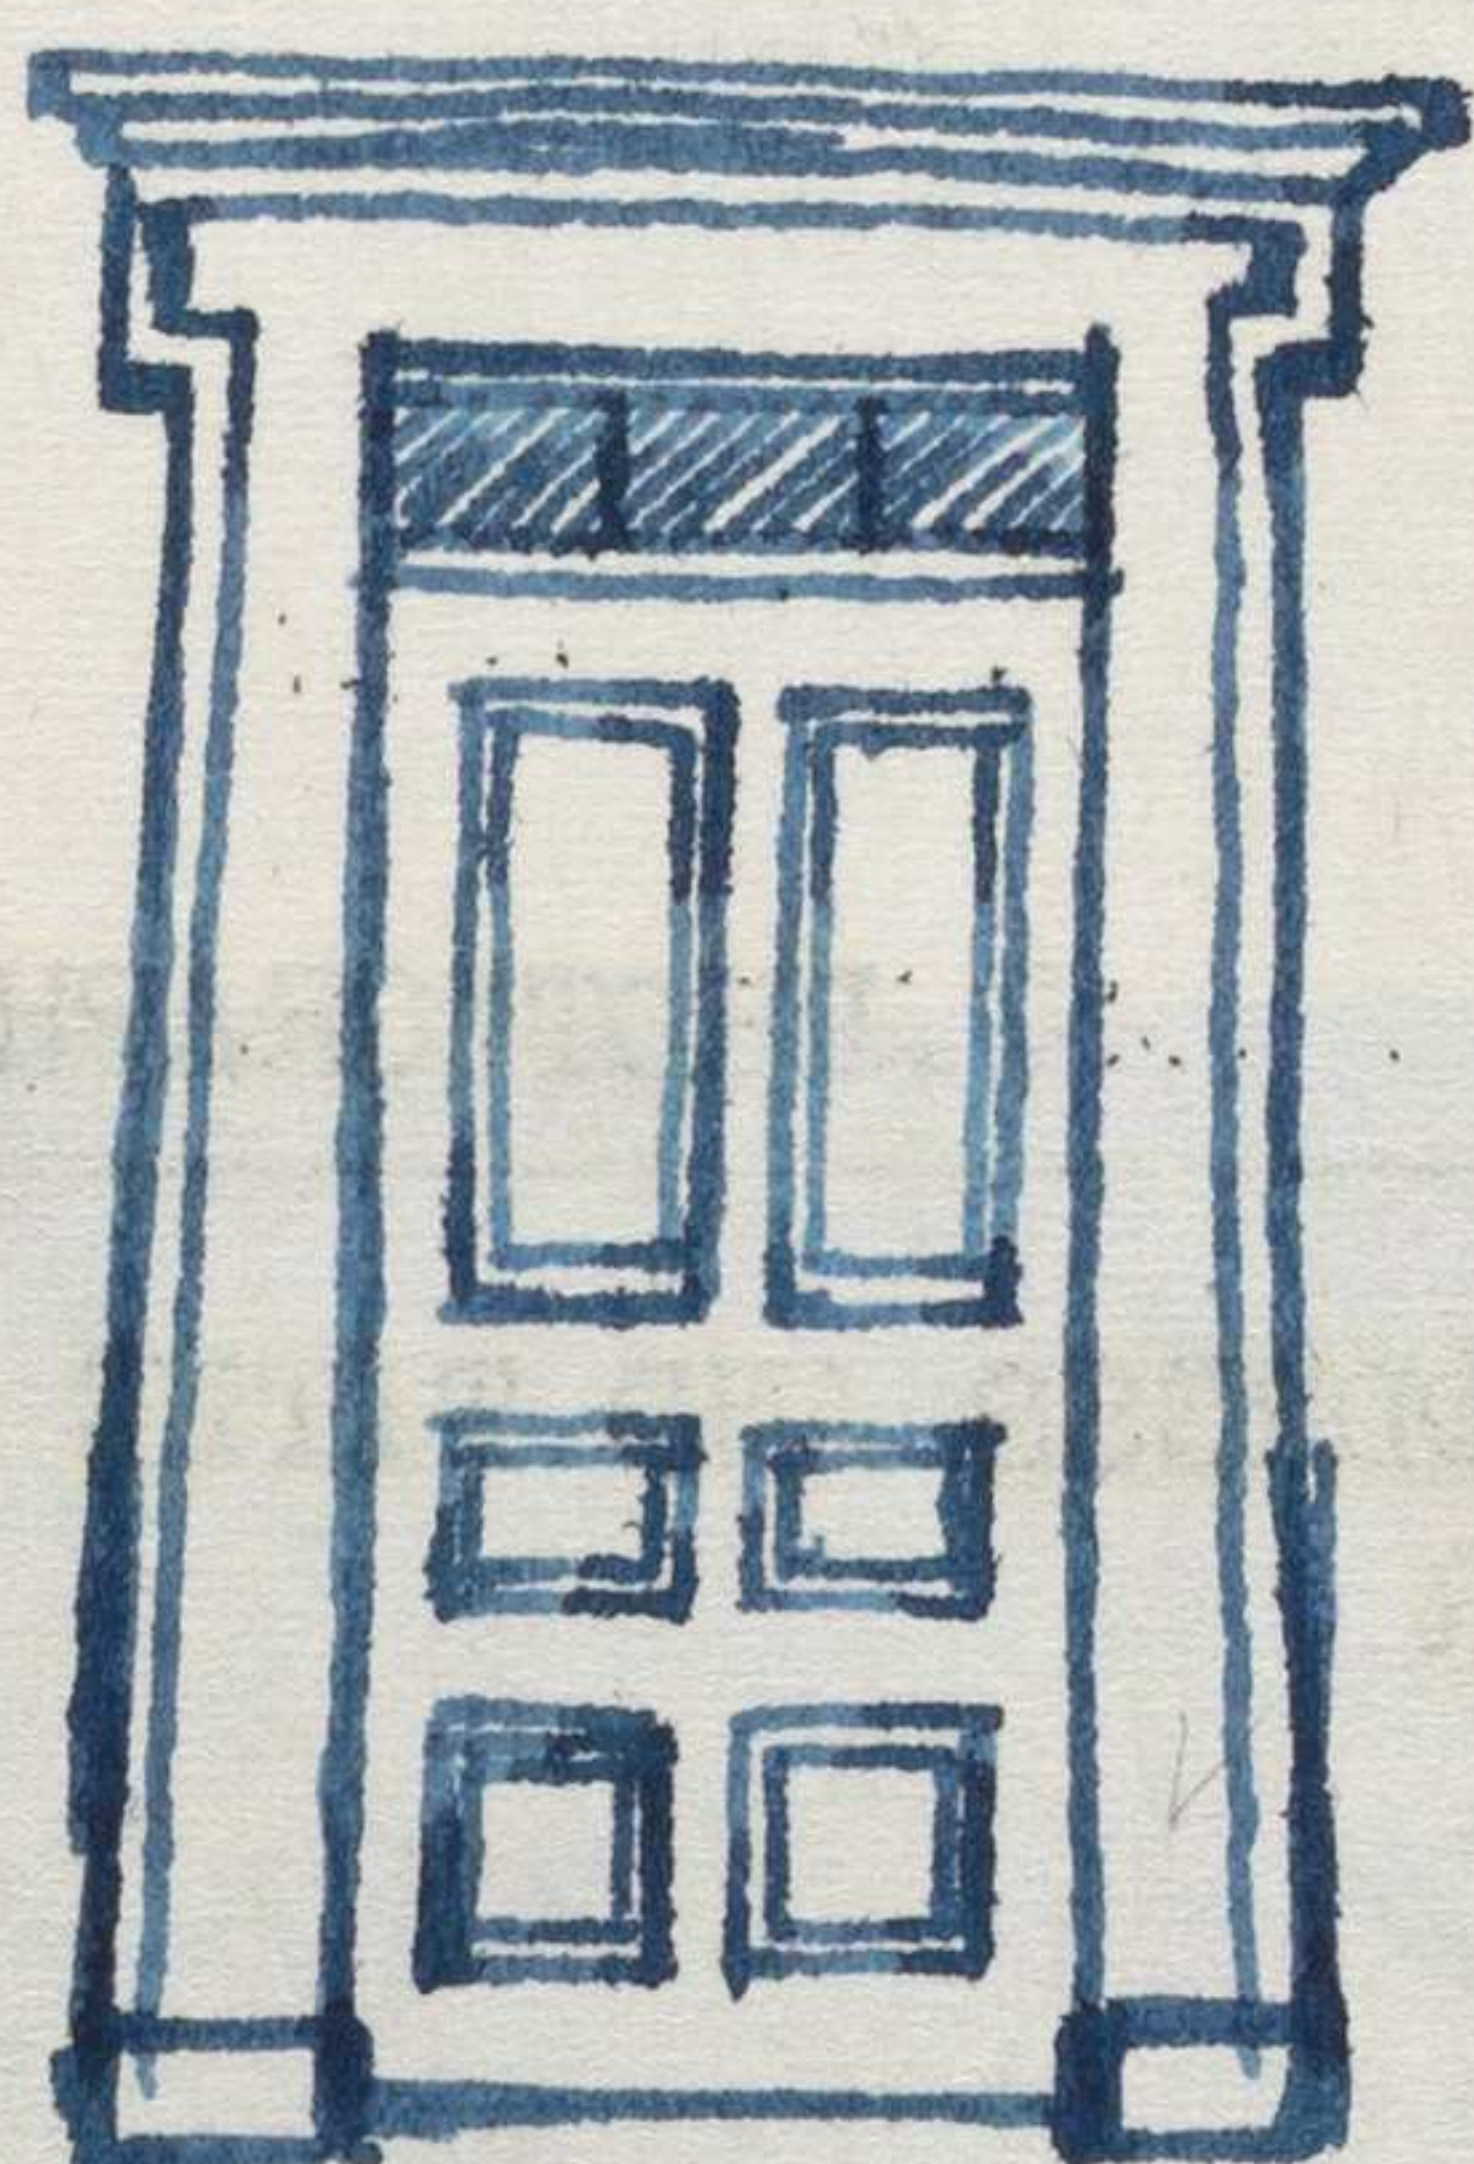
side doorway

recalled when the old steeple to the Third Meetinghouse was removed during its conversion to a Town Hall. The rope being used broke and left nearly all of Enfield's male population in a multitude of flailing legs and bruised bottoms. Apparently the removal of the spire was but one of numerous changes rendered at that time since there is all but nothing left of the original 1775 design. The building is now a good example of the Greek Revival. The foundation is now of brick. The roof is rather shallow and heavily corniced forming a facade pediment whose main decoration is an echoing recessed panel. Each ^(N-S) side has 5 bays with $\frac{1}{6}$ window on both floors. The facade below the pediment is decorated by 6 fine 24 flute Greek doric columns set on plinth blocks. All corners have paneled pilasters. Behind the colonnade is a wall ~~that~~ plain boarded and punctuated by a single 2nd story window and three doorways. The central door is wider (double) and higher than its fellows. All are original. The moldings are of the Greek type. The side doors have transoms.
